U.S. DEPARTMENT OF
ENERGY

Legacy
Management

2021 Annual Site Inspection and Monitoring Report for Uranium Mill Tailings Radiation Control Act Title II Disposal Sites

December 2021

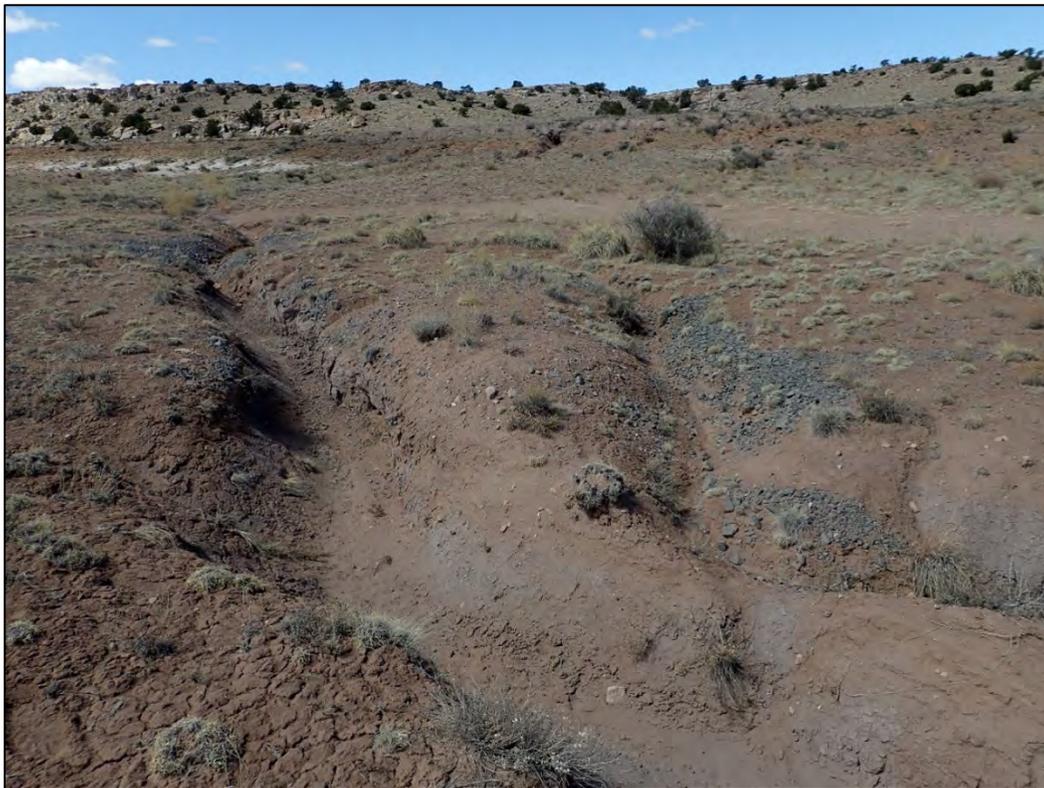
PL-2. Rilling Near Access Road, Road Repair Area

Inspectors also identified the need to repair erosion along the interior road. This work is proposed for 2022.

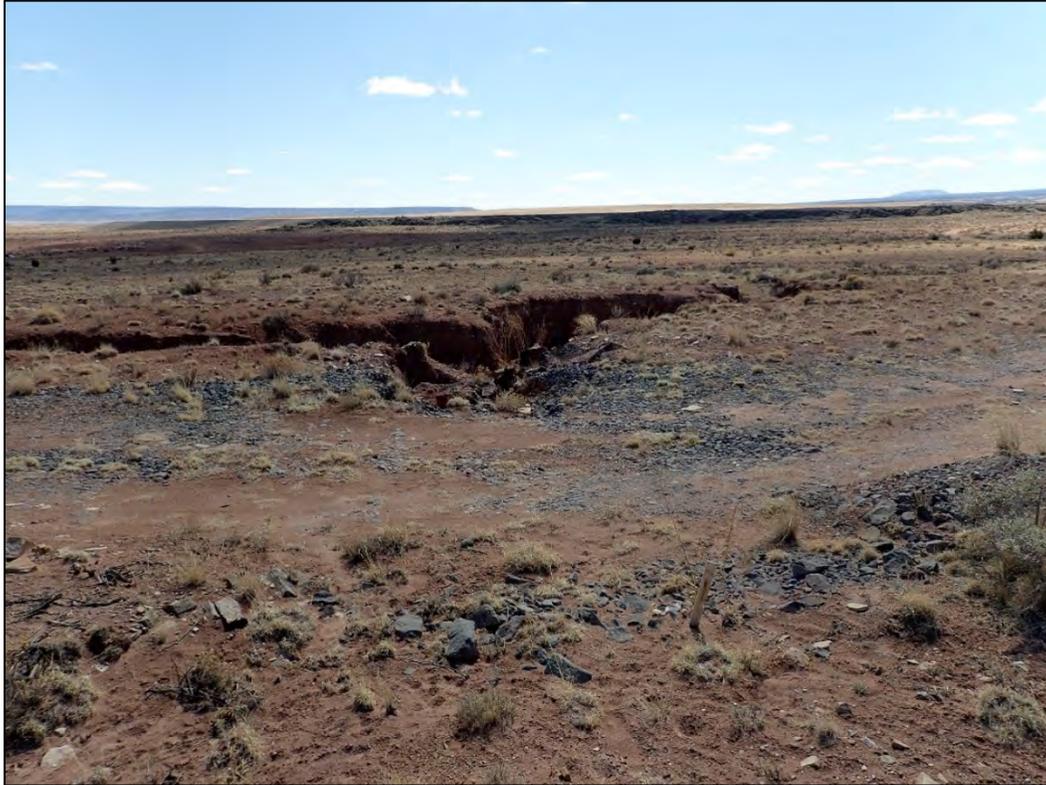
PL-3. Gully Near Access Road, Road Repair Area

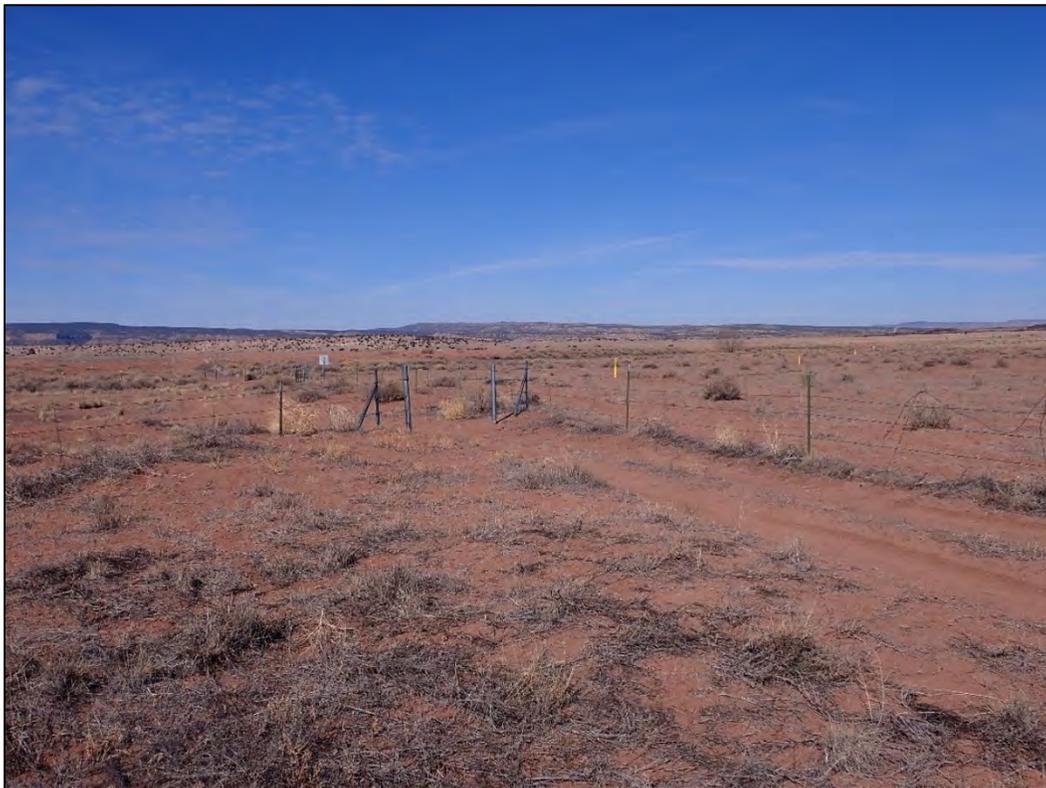
PL-4. Broken Fence Strands Near Perimeter Sign P6 (Repaired)

- Broken fence strands near perimeter sign P6
- Loose fence strands near perimeter sign P8
- Loose T-posts near boundary monument BM-5
- Downed perimeter sign P8
- Loose base of perimeter sign P6

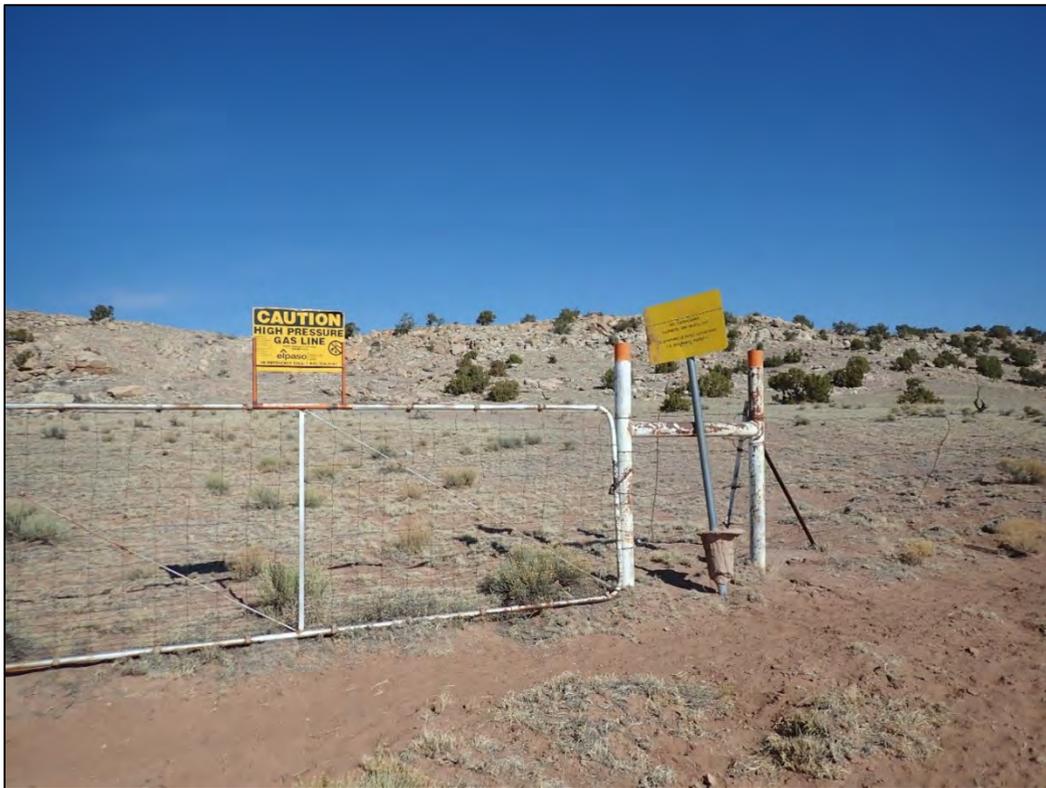
Fifty-five perimeter signs (warning and no-trespassing signs) are mounted on steel posts along the site boundary and around the main and carbonate tailings disposal cells (PL-5). Perimeter sign P8 was out of the ground (PL-6) and the base of perimeter sign P16 was loose (PL-7); both were repaired in a subsequent maintenance trip. Perimeter signs P3 and P10 have bullet hole damage but are legible. No other maintenance needs were identified.

PL-6. Perimeter Sign P8

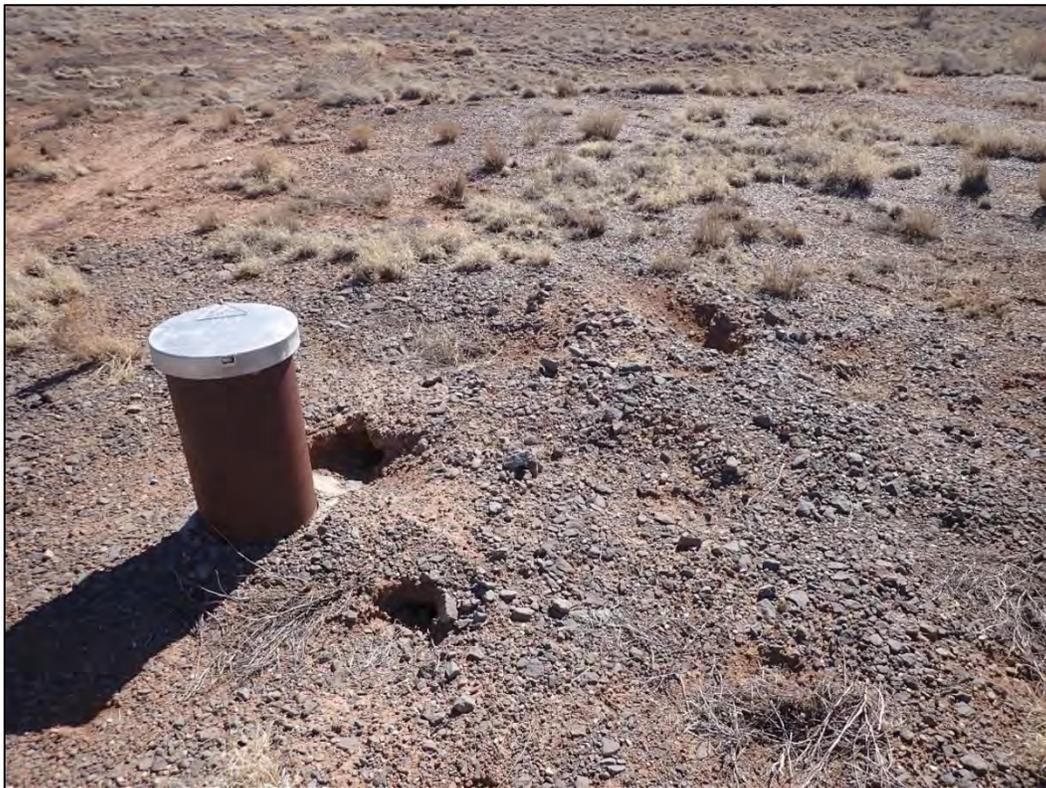
PL-12. Well F(M) and Three Animal Burrows

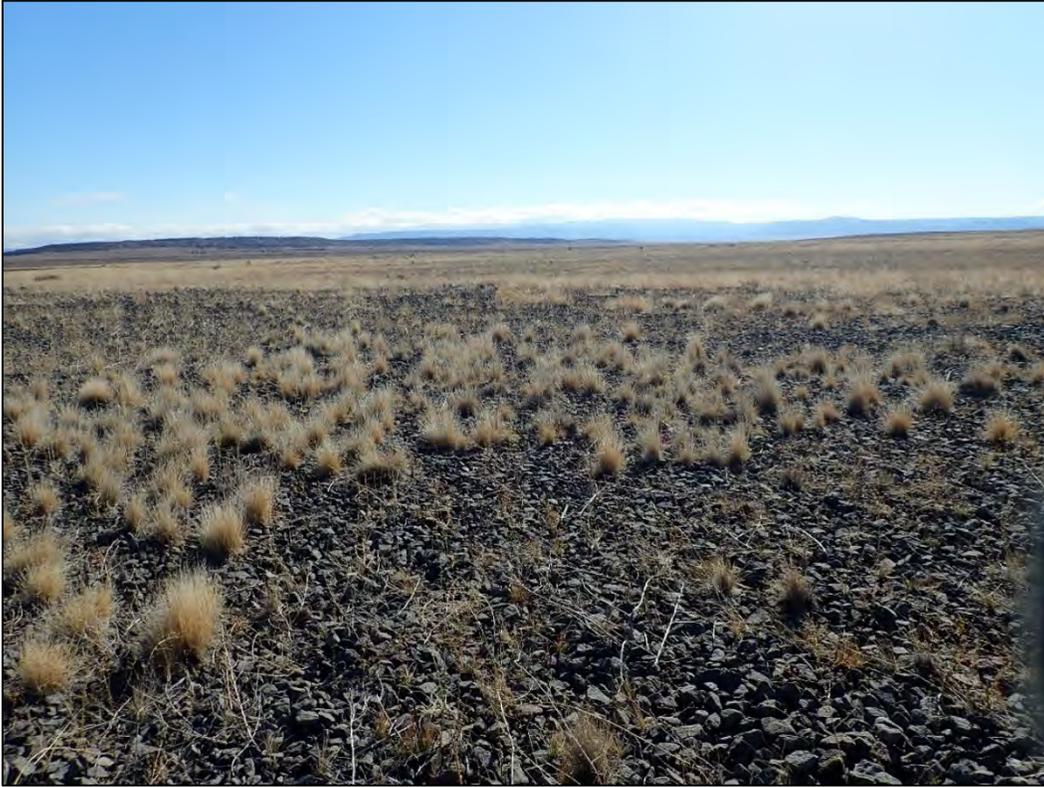
Plant encroachment (by annual weeds, perennial grasses and forbs, and scattered perennial shrubs) continues on the main tailings disposal cell top and side slopes (PL-13). Siberian elm saplings on the top slope are managed to prevent the establishment of trees that could damage the main tailings disposal cell cover materials.

PL-13. Main Tailings Disposal Cell Top Slope

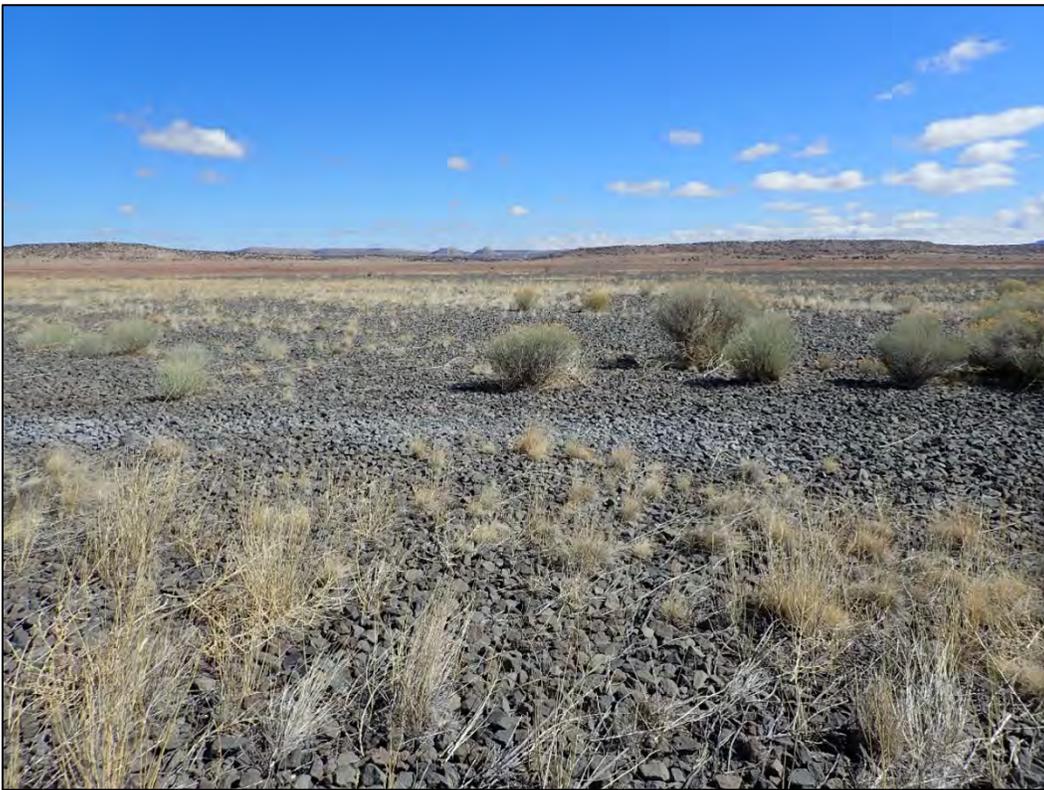
PL-14. Main Tailings Disposal Cell Top Slope Depressed Area with Evaporites

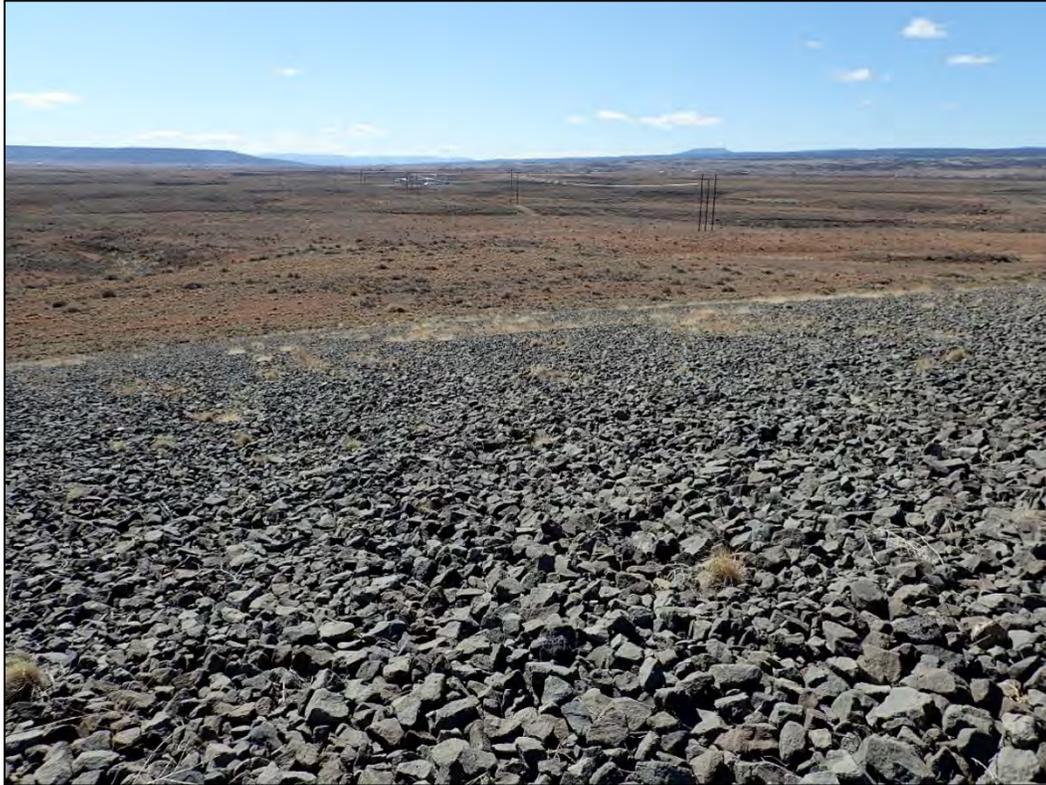
The side slopes and toe of the main tailings disposal cell were inspected for signs of erosion or sediment deposition. A new area of minor depression was observed on the south side slope with an approximate length of 10 feet, width of 20 feet, and depth of 10 to 12 inches (PL-17). Another area of minor depression was observed on the south side slope during the 2018 annual inspection, but it could not be identified during the 2021 inspection. The minor depression will be removed from future inspection maps unless it is identified in subsequent inspections or in the 2021 lidar survey. An area of potential settlement was observed on the north side slope during the 2020 annual inspection. Inspectors observed the area, but no apparent changes were noted (PL-18). The side slopes will continue to be observed for depressions. Identified depressions and settlement will continue to be monitored and will be evaluated using lidar. During the 2019 annual inspection, minor rills with a maximum depth of 6 inches were observed at the base of the east side slope; minor rills with a maximum depth of 8 inches were observed at the base of the main tailings disposal cell south bench. The rills did not appear to increase in depth or extent (PL-19). During the 2020 annual inspection, a linear desiccation crack was observed along the base of the east side slope. The desiccation crack did not appear to increase in depth or extent. LM will continue to monitor the rills and crack for potential impact to the main tailings disposal cell and south bench area. No sediment deposits were present along the toe. No maintenance needs for the side slopes or acid tailings and south bench disposal areas were identified.

PL-17. Area of Possible Depression on Main Tailings Disposal Cell South Side Slope

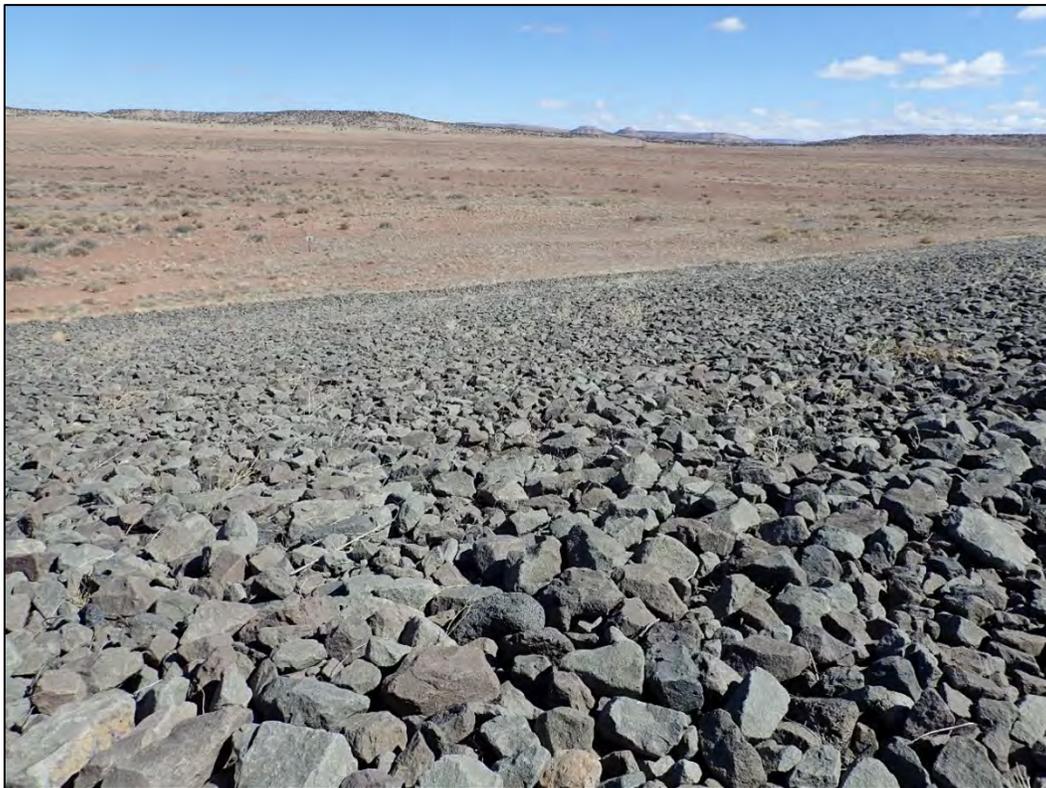
PL-18. Potential Settlement on the North Side Slope of the Main Tailings Disposal Cell

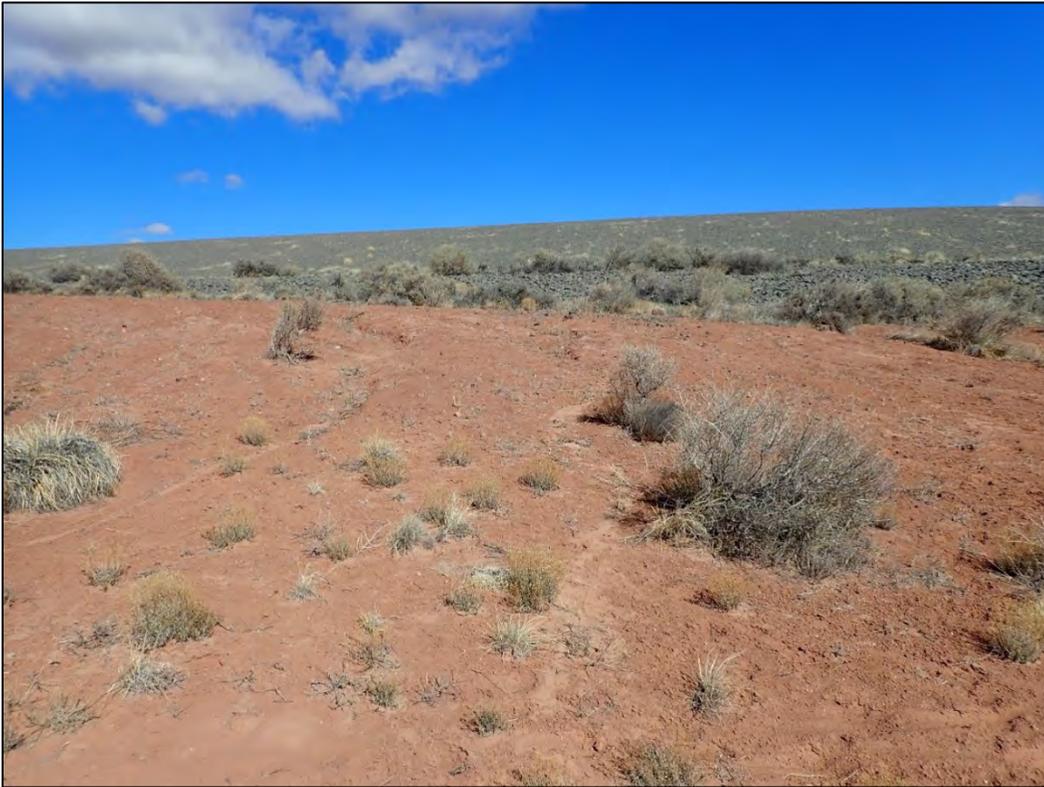
PL-19. Rilling North of Perimeter Sign P24

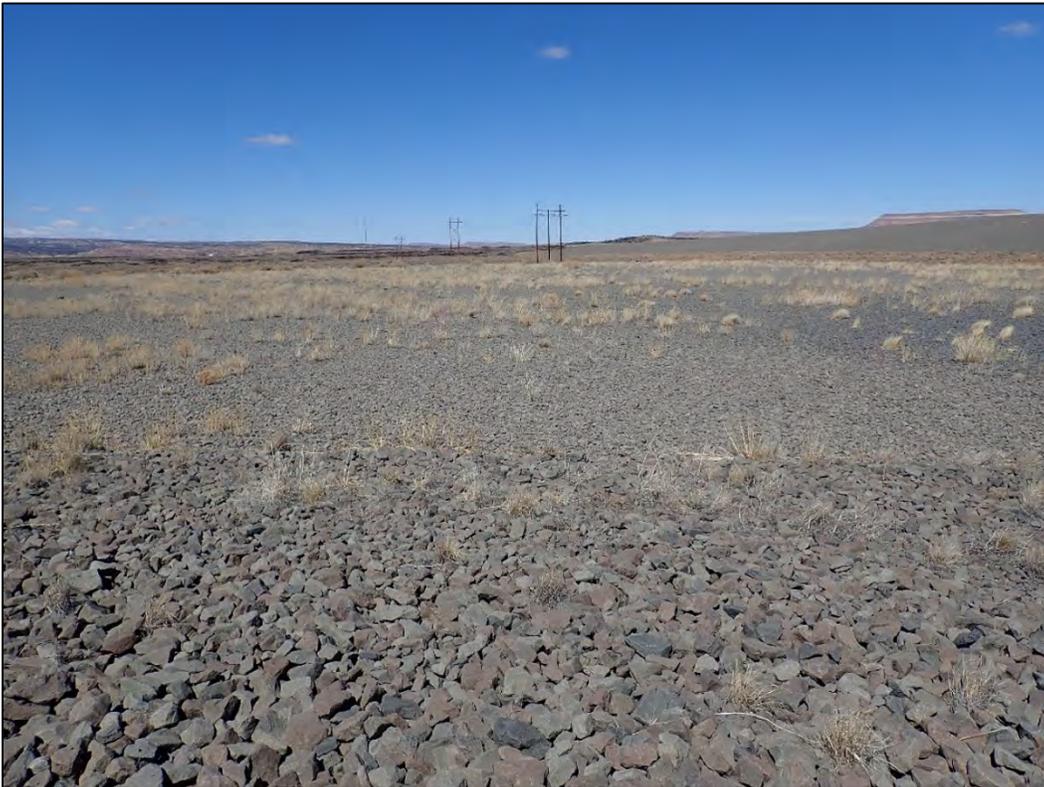
PL-20 Shallow Depression on the Northwest Extension of the Carbonate Tailings Disposal Cell (Dry)

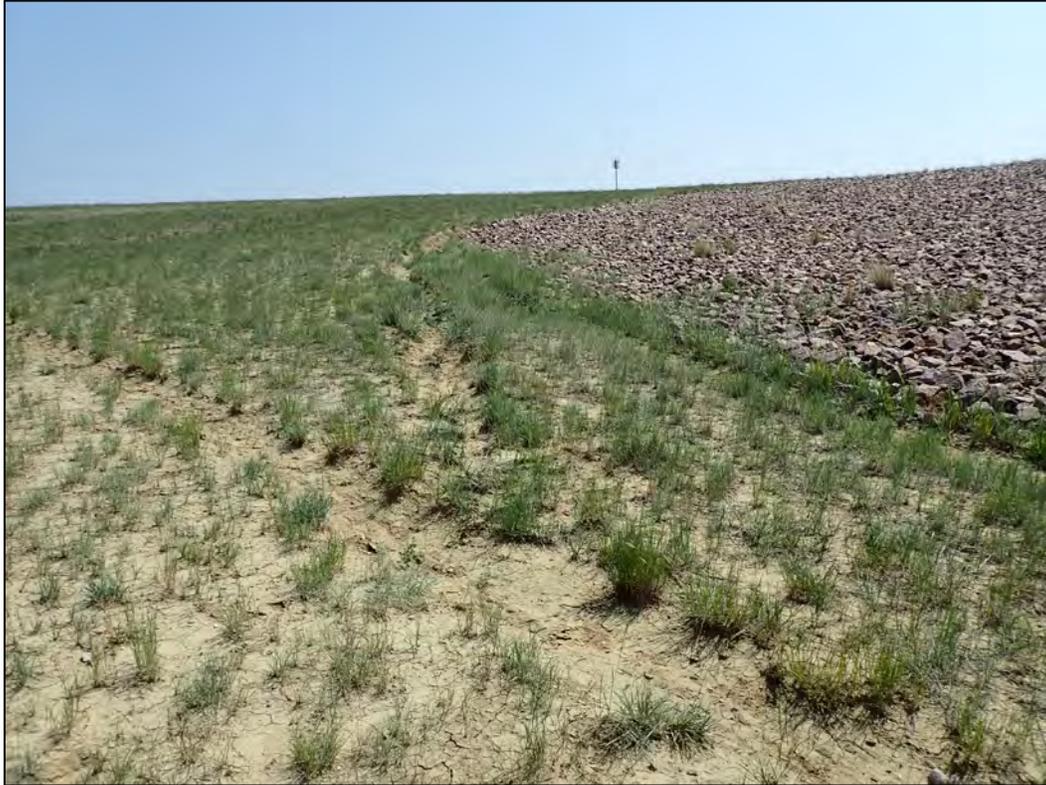
PL-7. Cattle-Caused Path Along Riprap Near P13
